NATIONAL PROGRAM FOR INSPECTION OF NON-FEDERAL DAMS
SUNRISE LAKE DAM (NH. (U) CORPS OF ENGINEERS WALTHAM MA
NEW ENGLAND DIV AUG 78

SUNRISE LAKE DAM

AUG 1978

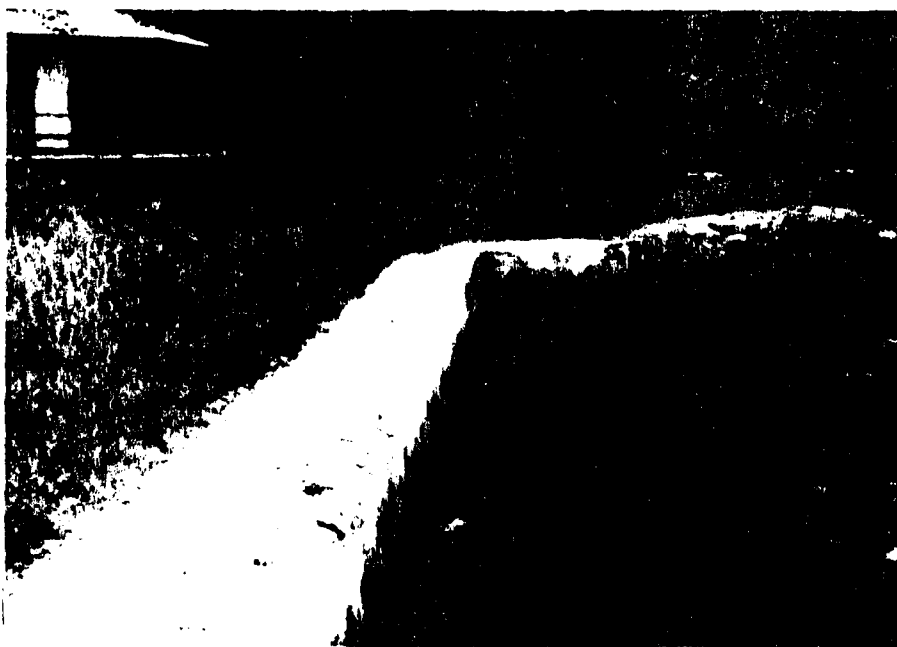
The concrete facing on the upstream side of the central section of the dam, which was built in 1939, is badly deteriorated and spalled. (See Appendix C - Figures 7, 8, and 9.) Brush is growing on the upstream facing between the central section and the west abutment. Brush and trees are growing on the crest and on the upstream face between the central section and the east abutment. (See Appendix C - Figure 10.) Near the top of the downstream dry masonry wall are some trees and stumps. An extensive growth of trees and brush was noted immediately downstream of the dam next to the downstream dry masonry wall.

Figure 7 - Looking west along the upstream face of the dam, taken from the vicinity of the gatehouse. Note the residence immediately downstream of the dam in the upper left corner of the photo.
